3.4 長期型自己浮上式海底地震計の整備とその試験運用について

3.4.1 背景

本報告では、今回新たに整備した長期型OBSの構成、仕様、整備方法についての概要、そしてこの長期型OBSを用いて実施した房総半島沖での試験的な海域地震観測とその結果について報告する。特に、平成25年12月現在では対策が施され問題点は解消されているが、平成24年9月の回収・再設置航海で発生した、長期型OBSの音響トランスポンダの不具合についても報告しておく。

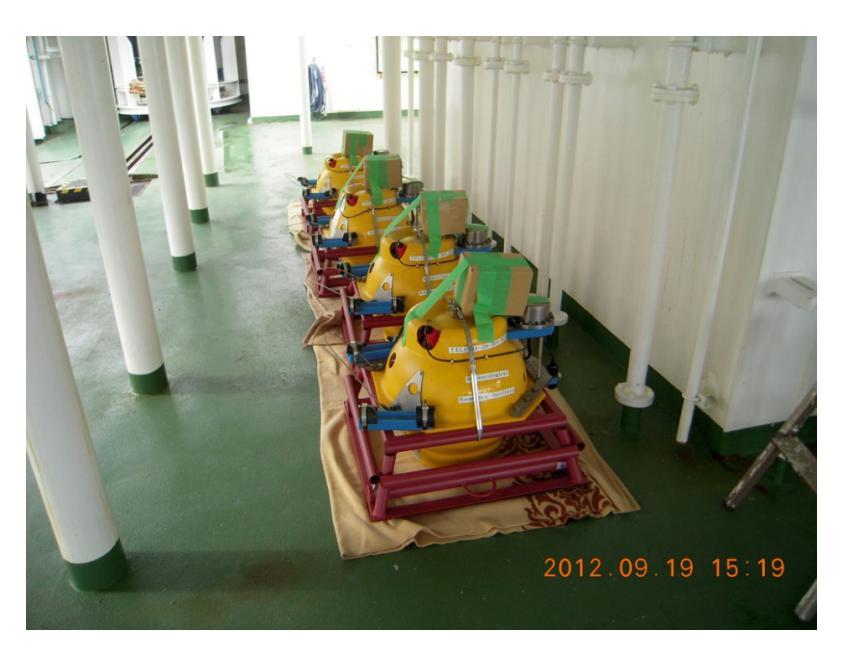
前年度に引き続き平成24年度も(株)東京測振製の短期型OBS4台(#I-011、#I-012、#I-019、#I-021)を長期型OBS に改造した。平成24年9月下旬、この4台を凌風丸に搭載し(Fig. 3.4.5)、房総半島沖OBS回収・再設置航海(RF12-07 次航海)に臨んだ。この搭載位置は通常のOBSオペレーション時と同じ位置である。ところが、9月21日出港直後の夕 方になって、昨年度の設置航海時と同様の場所に搭載していた、長期型OBS#I-019の音響トランスポンダが不規則な 間隔で自発的に音を発信し異常動作していることが確認された。このため同日夕方、チェックシートに基づき残り3 台の長期型OBSの音響トランスポンダの応答確認テストを実施したところ、#I-021の音響トランスポンダが応答不良 かつ「距離応答」に相当する音を不規則なタイミングで自発的に発信していること、また、残りの#I-011と#I-012がし ばしば規定どおりの動作をせずに応答不良になっていることが確認された。船から音響トランスポンダメーカーの技 術者と連絡を取り、可能な限りの対策を講じたが、動作不良が改善せず、このような状態で再設置作業を強行しても1 年後に回収できる見通しが立たないことから、最終的に9月24日夕刻を以て再設置用に持ち込んだ4台の長期型OBSの 投入を中止した。この音響トランスポンダの動作不良に関して、9月19日のOBS観測資機材の凌風丸への搬入時点から 凌風丸航海終了後の東京港岸壁(お台場埠頭)着岸時における動作確認作業までの時系列をTable 3.4.3にまとめた。

Fig. 3.4.5 Photograph of long-term OBSs onboard R/V *Ryofu-Maru* during cruise RF12-07. The OBSs were placed on the working deck with blankets under them about 5–10 m behind the shelter of a CTD hangar.

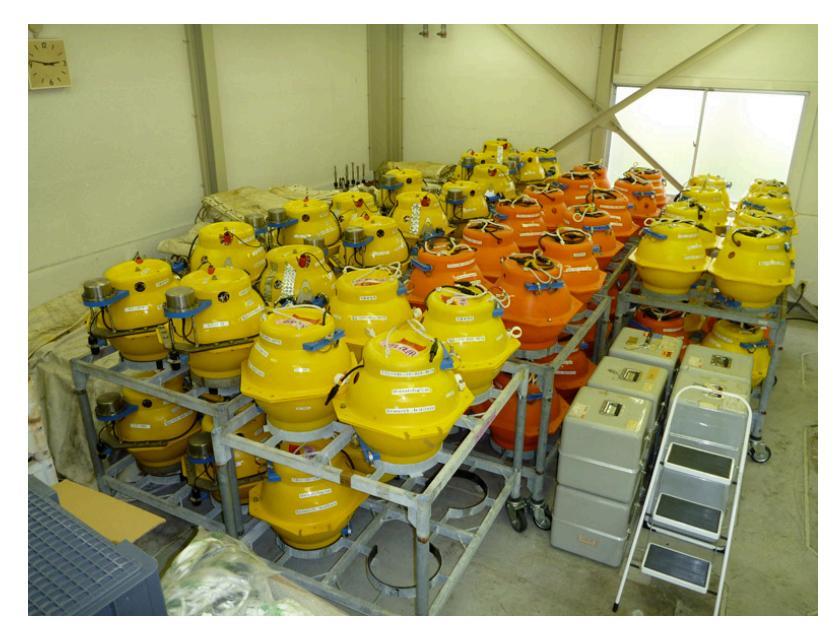
なお、音響トランスポンダの動作不良問題については、RF12-07 次航海終了直後の9月下旬に、動作不良のトラン スポンダを日油技研工業(株)に送り返し、10月下旬まで原因究明のため同社にて温度試験、振動試験が実施された。 その結果、(1)夏場の高温環境下と冬場の低温環境下にさらされる OBS 保管場所で OBS を保管した (Fig. 3.4.6)ため、 OBS 音響トランスポンダ送受波器(逆鍋型形状のチタン製容器)の内部のシリコーンオイル中に真空の隙間が生じて いた可能性があること、さらに、(2)船のエンジン主機や発電機による振動ノイズによって OBS 音響トランスポンダ 送受波器容器内部にキャビテーション現象が生じ音響性能を劣化させた可能性があること、の2つが原因であろうと 推測された。これに基づき以下の対策案が考えられた:(i)室内で深海相当の水圧を加えることにより、OBS 音響ト ランスポンダ送受波器に発生した真空の隙間を解消する、(ii)OBS を船に搭載する際に、OBS の下に振動緩衝材(免 震マット)を敷くことにより、船の甲板から OBS 音響トランスポンダ送受波器に伝わる船の振動ノイズを低減し、キ ャビテーション現象が生じるのを防ぐ。これらの対応策を検証するために室内実験が行われ、その有効性を示唆する 実験結果が得られた(東京測振・日油技研工業, 2013)。

Fig. 3.4.6 Photograph inside the room used for storage of OBSs at the Meteorological Research Institute. OBSs in the first two rows on the left are OBSs built by Tokyo Sokushin Co., Ltd, and were transferred from the Hydrographic and Oceanographic Department of the Japan Coast Guard to the Meteorological Research Institute. Eight of them were remodeled from short-term OBSs into long-term OBSs in 2011 and 2012.

なお、現在の OBS 保管場には冷暖房施設が整備されておらず、現状のままでは東京測振製の OBS 音響トランスポ ンダ送受波器の送受波能力を劣化させてしまう可能性が高い。これを防ぐためには、現在の OBS 保管場に冷暖房機器 を取り付けて保管場の気温を一定の範囲に保つか、あるいは、組立の前に OBS 音響トランスポンダ送受波器に水深 2000 m 以深の水圧を掛けてトランスポンダ送受波器の容器を押し内部の隙間を解消するか、を行う必要がある。

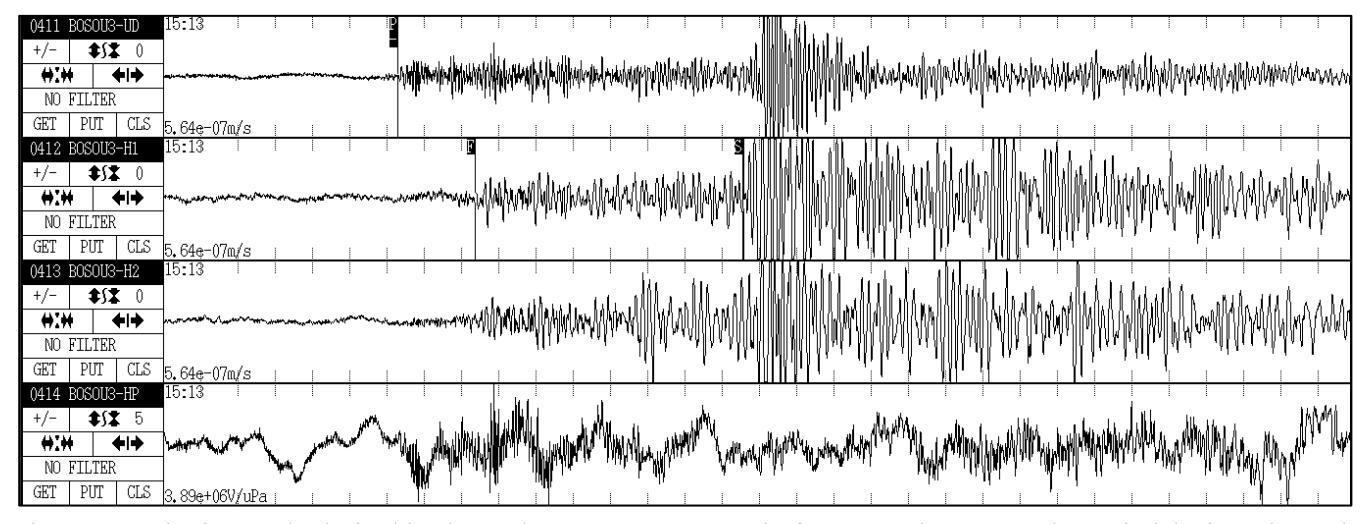
Fig. 3.4.7 に、平成 23 年 11 月から平成 24 年 9 月にかけて房総半島沖の海底において、長期型 OBS によって記録された観測波形の例を示す。上下動・水平動 2 成分・ハイドロフォンの各信号が正常に記録されていることが確認された。当改造は、観測期間の長期化を図るため、電力消費を低減させるレコーダー全般にわたる改造であったが、レコード機能自体は正常に動作していた。

Fig. 3.4.7 Seismic records obtained by the U3 long-term OBS. Records, from top to bottom, are the vertical, horizontal-1, and horizontal-2 components, and hydrophone data.
